Planning Commission meeting comments repeated here for convenience:

Monday July 19, 2021 Storm water backup images

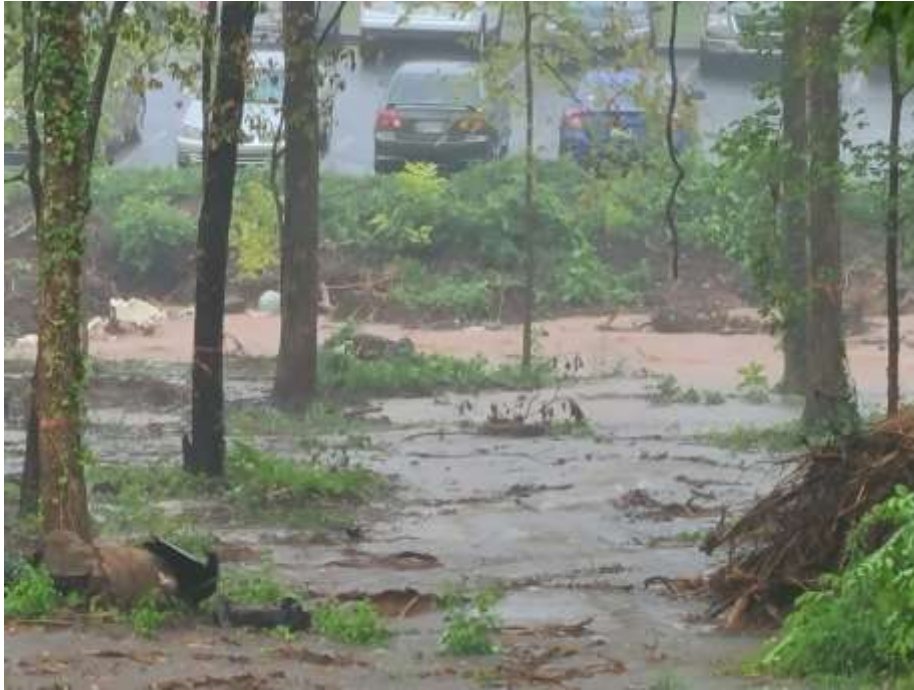
Image 1 & 2: 0 E. Meadecrest Dr property showing water flow.

Image 1: Note the significant amount of water. This is all flowing very fast into the southeast corner of the property. This ditch is well over 6 feet deep in places.

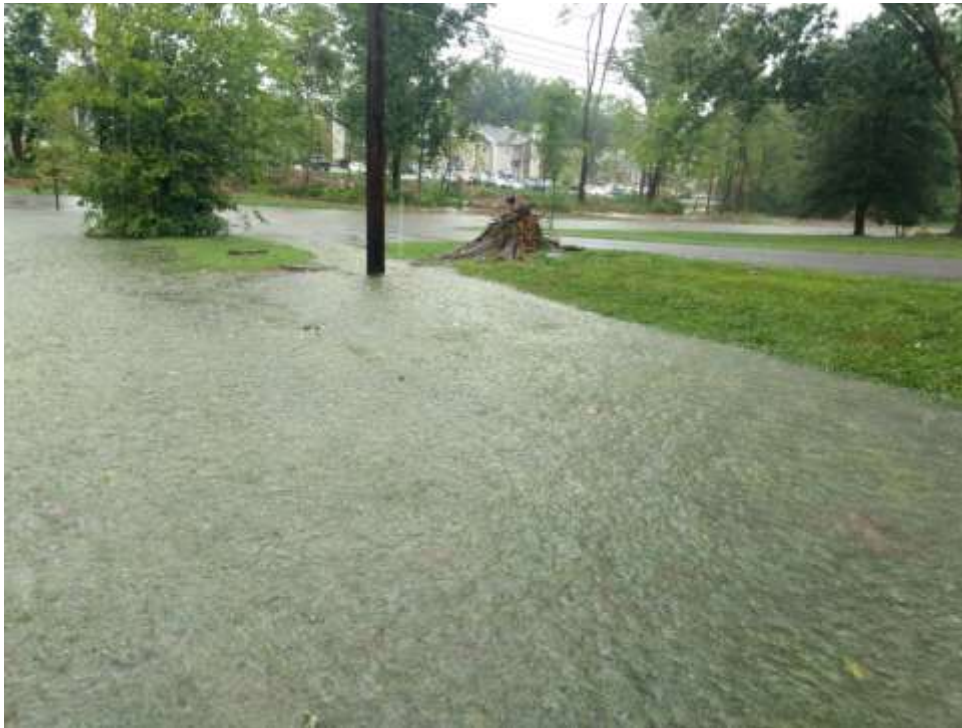
Images 3 & 4: Flooding from same storm across E Meadecrest at the intersection of Walker Springs

Image 3: This amount of flooding has never been seen by this home owner on her property.

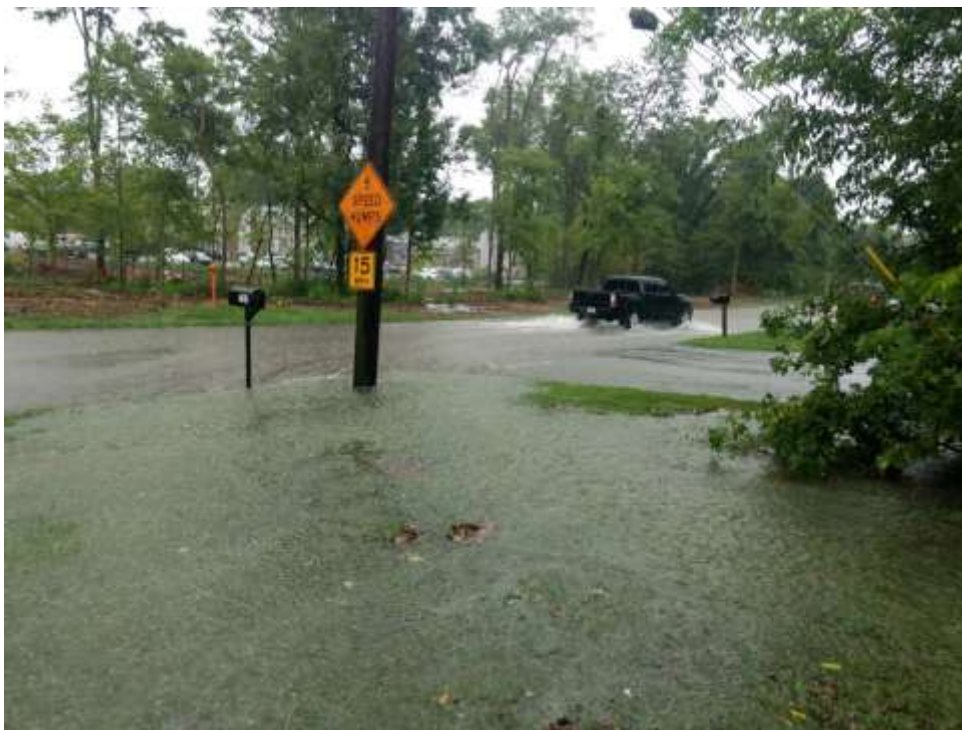
Image 4: Significant water in yard and on E. Meadecrest Dr.

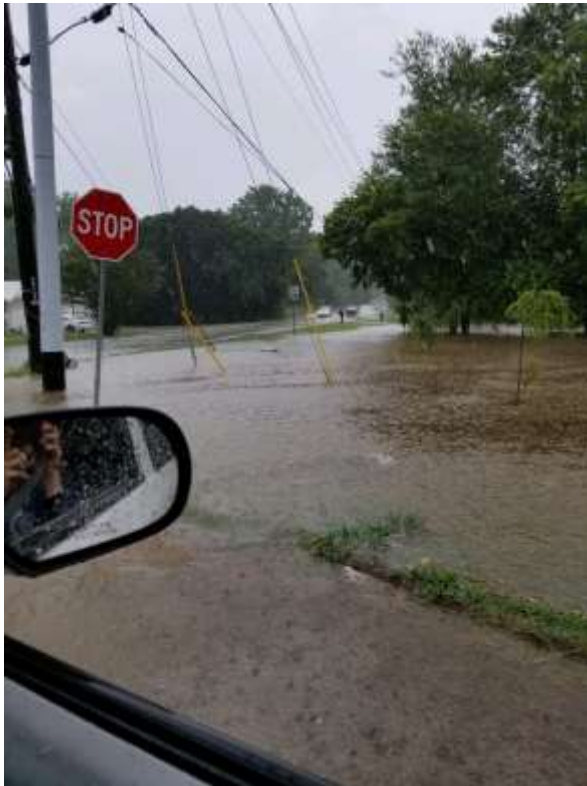
Images 5 & 6 taken from the corner of Woodbrier Rd and Walker Springs Rd

Image 5: (left) Note the water about to crest Walker Springs. There is a depth of about 4 feet close to the Walker Springs.

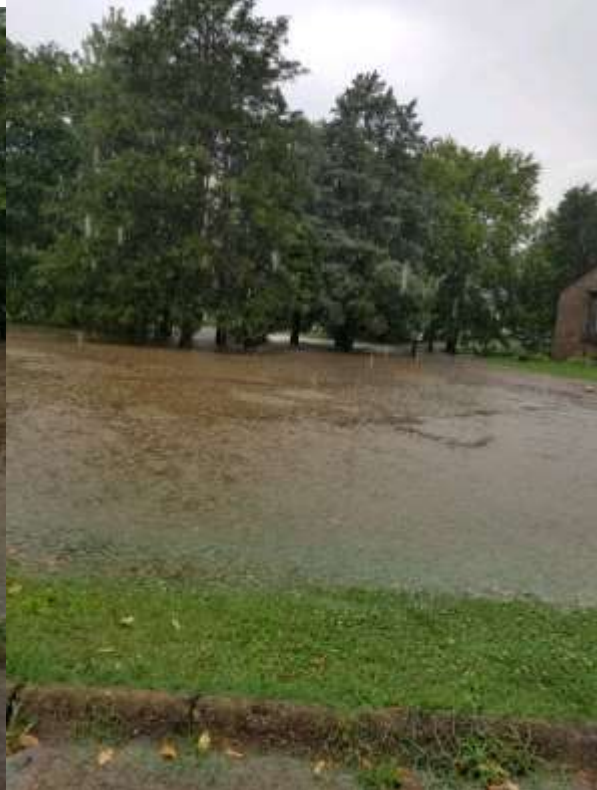
Image 6: (right) Note the water proximity to the home on the right of the picture.

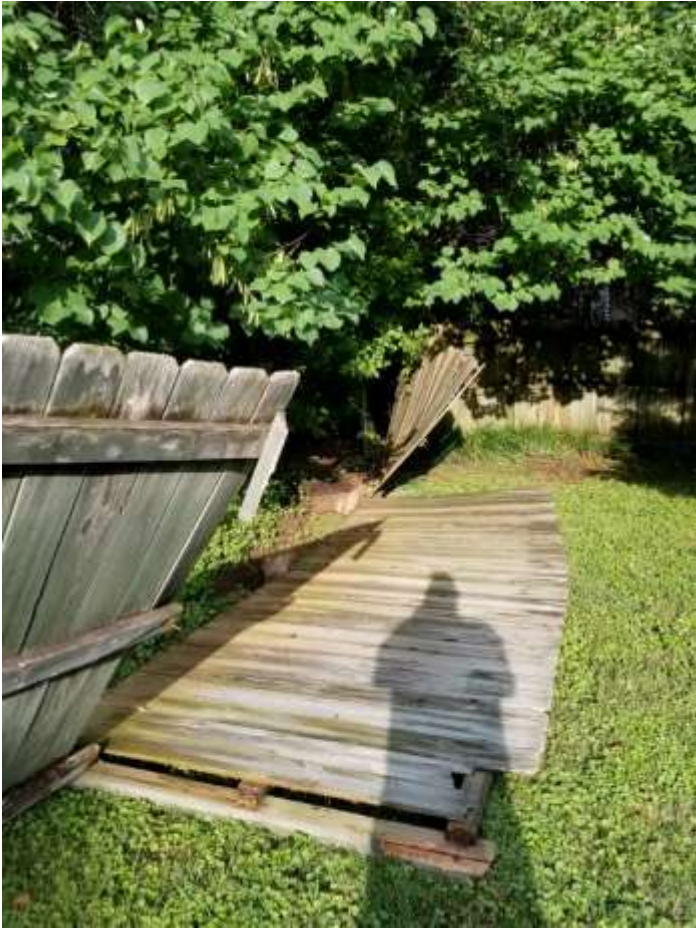
Image 7: Storm damage at the 2nd home downstream of the southeast corner of the property.
