RE: Agenda Item No. 8 – File Nos. 11-B-21-SP and 11-F-21-RZ
December 9, 2021 Planning Commission Meeting

Subject: **Hydrologic Determination Report**
Sevierville Pike Project
Knox County, Tennessee
GEOServices Project No. 24-21945

**HYDROLOGIC DETERMINATION REPORT
FOR
SEVIERVILLE PIKE PROJECT
KNOX COUNTY, TENNESSEE**

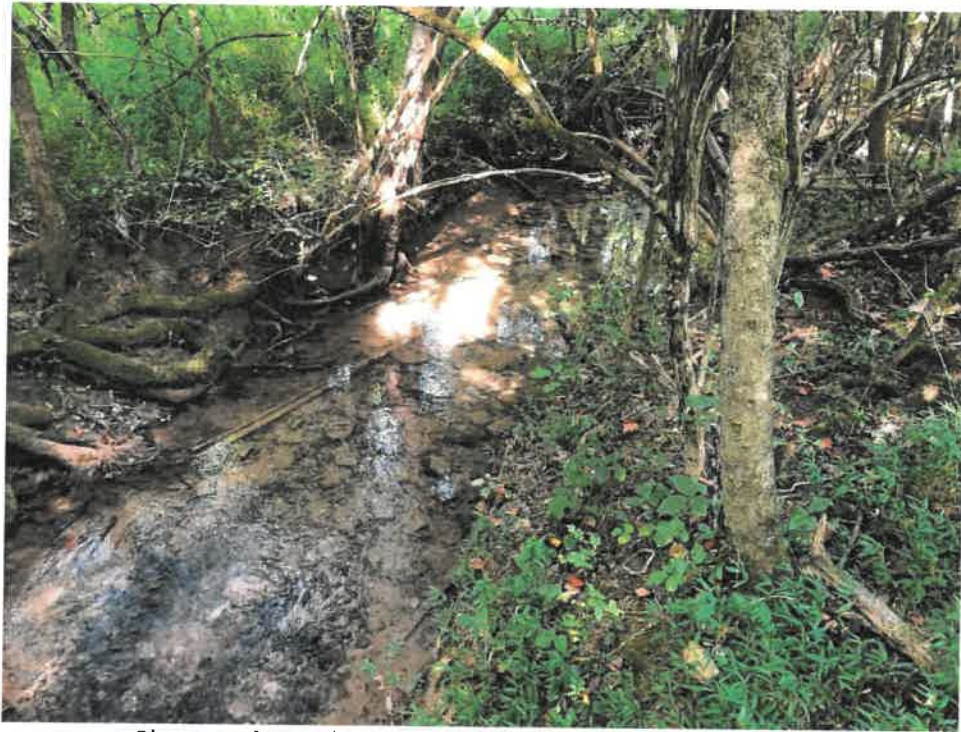
Photo 1: Photo of Channel 1 as it enters the subject property

UT Hines Creek, Channel 1 – Stream due to secondary stream indicators; a secondary score of 31.0 was calculated using a rigorous and reasonable amount of effort.

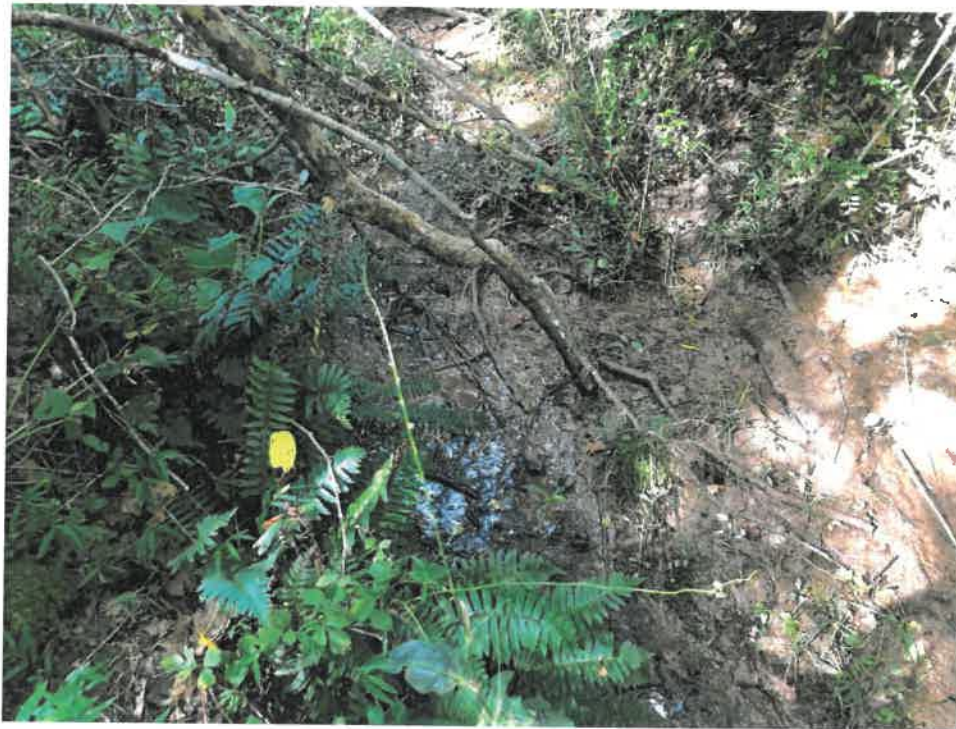
Photo 2: Photo of Channel 2 as it enters the subject parcel

UT Hines Creek, Channel 2 – Stream due to secondary stream indicators; a secondary score of 20.0 was calculated using a rigorous and reasonable amount of effort.

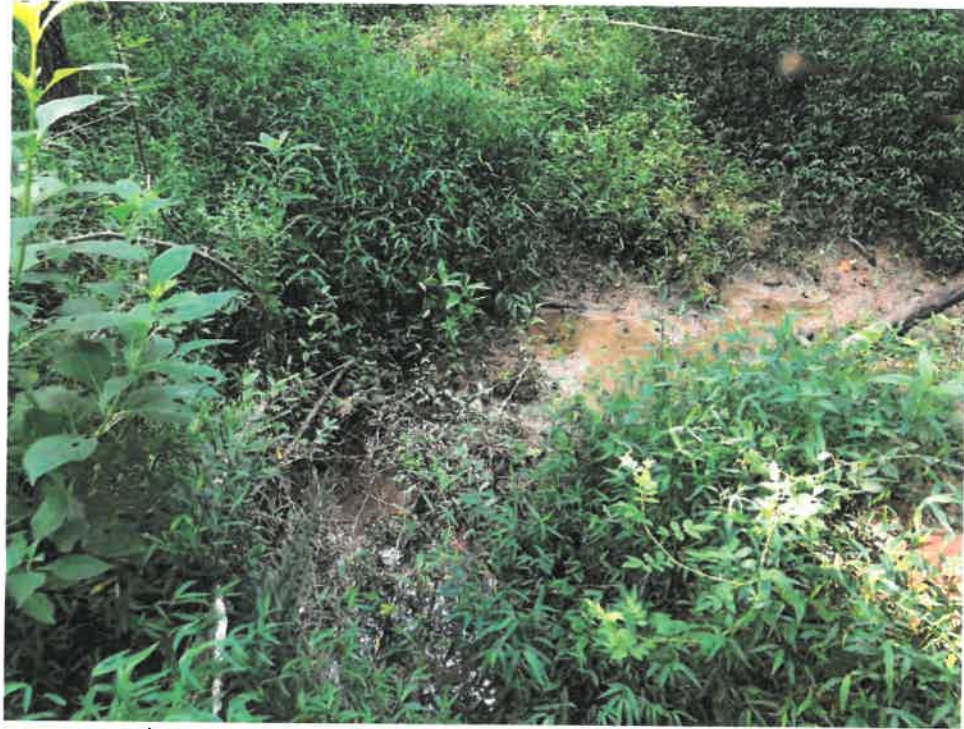
Photo 3: Photo of Channel 2 at the confluence with Channel 1

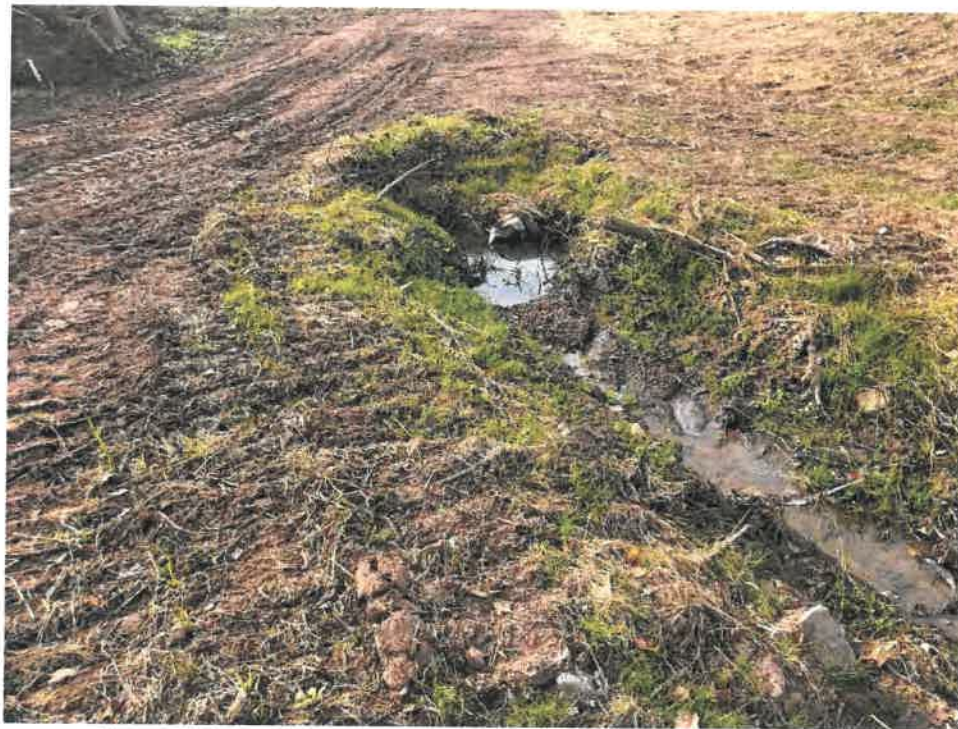
**Photo 4: Channel 3 originates with a culvert, acting as a springhead;
no water source could be found upgradient of this location**

UT Hines Creek, Channel 3 – Stream due to primary and secondary stream indicators; a secondary score of 21.5 was calculated using a rigorous and reasonable amount of effort. The channel has been recently disturbed and the alterations impact the score.

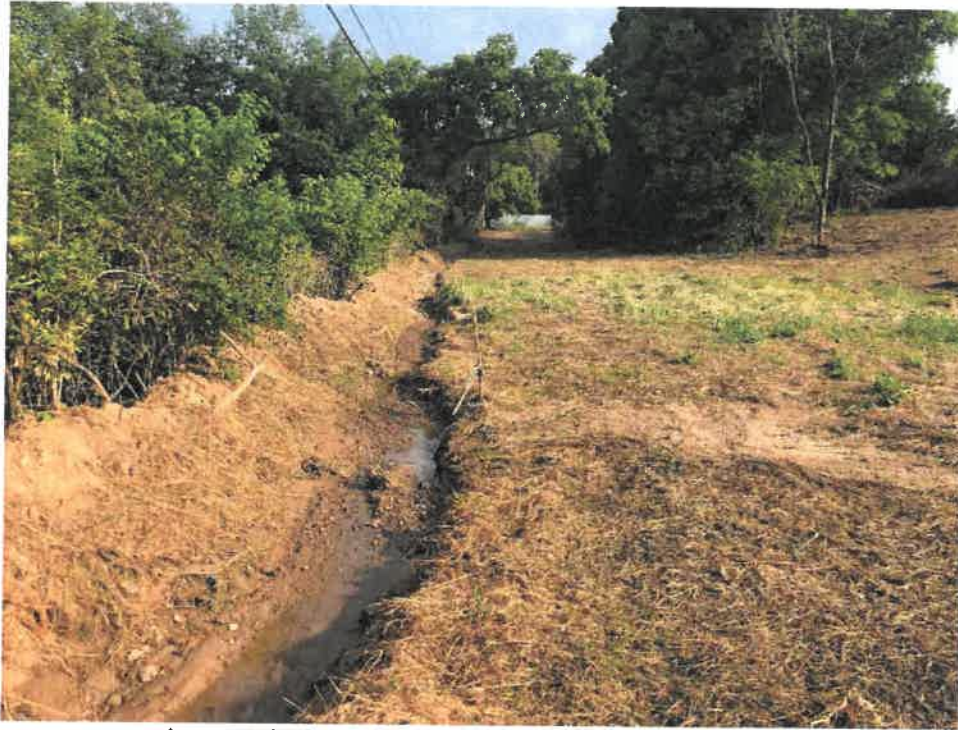
Photo 5: The lower section of Channel 3 has been altered

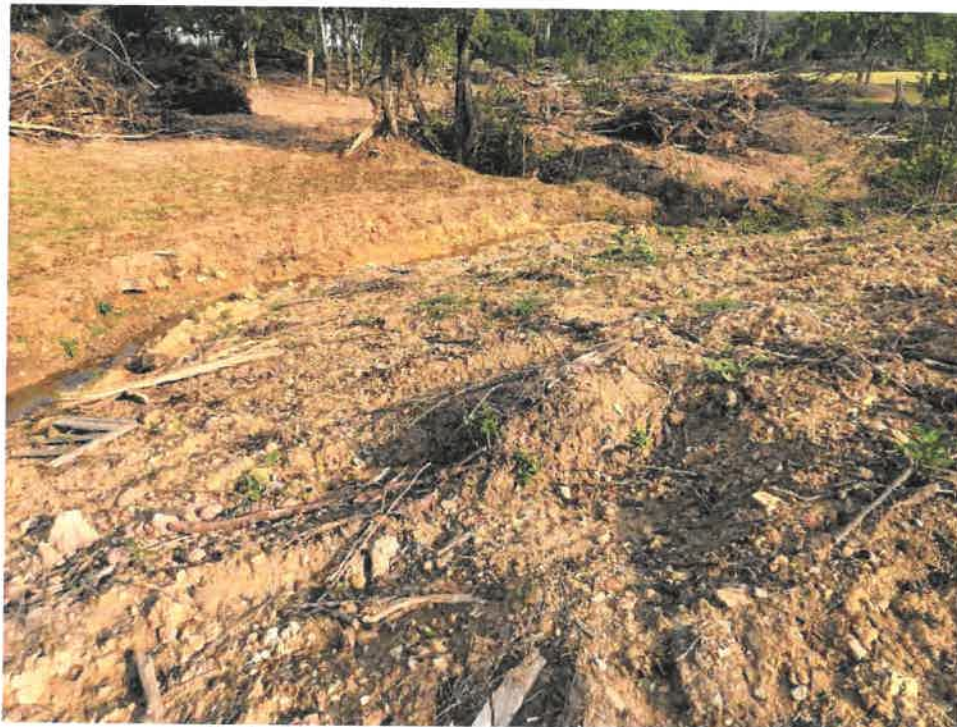
Photo 6: Typical representation of the Channel 3

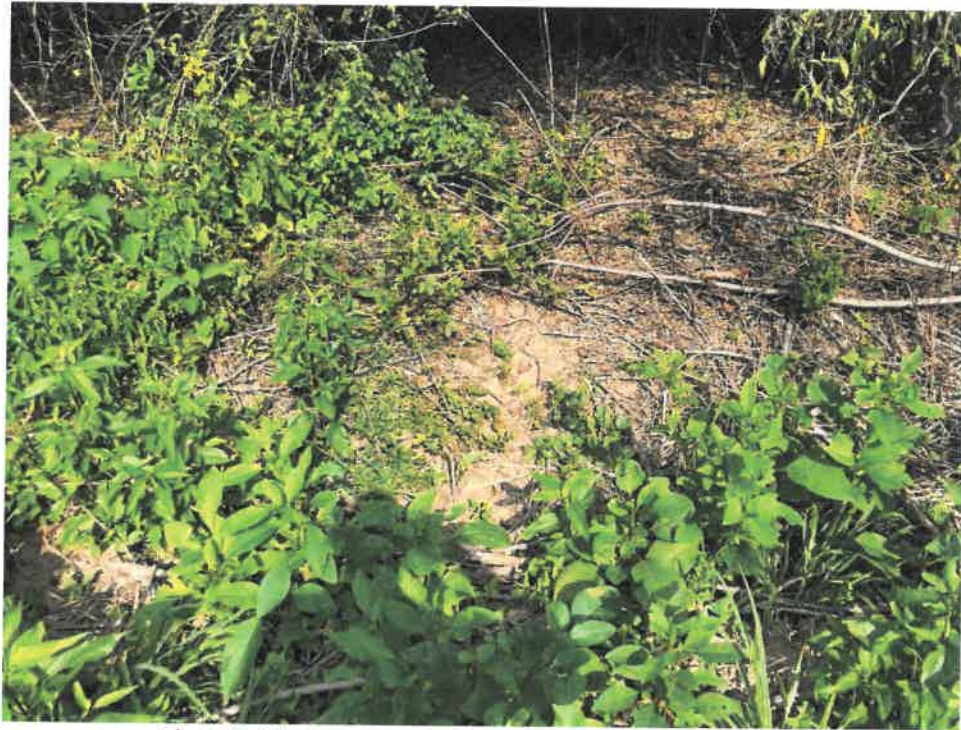
Photo 7: Photo of Channel 4 as it exits the subject parcel

UT Hines Creek, Channel 4 – Wet Weather Conveyance due to secondary stream indicators; a secondary score of 11.0 was calculated using a rigorous and reasonable amount of effort.

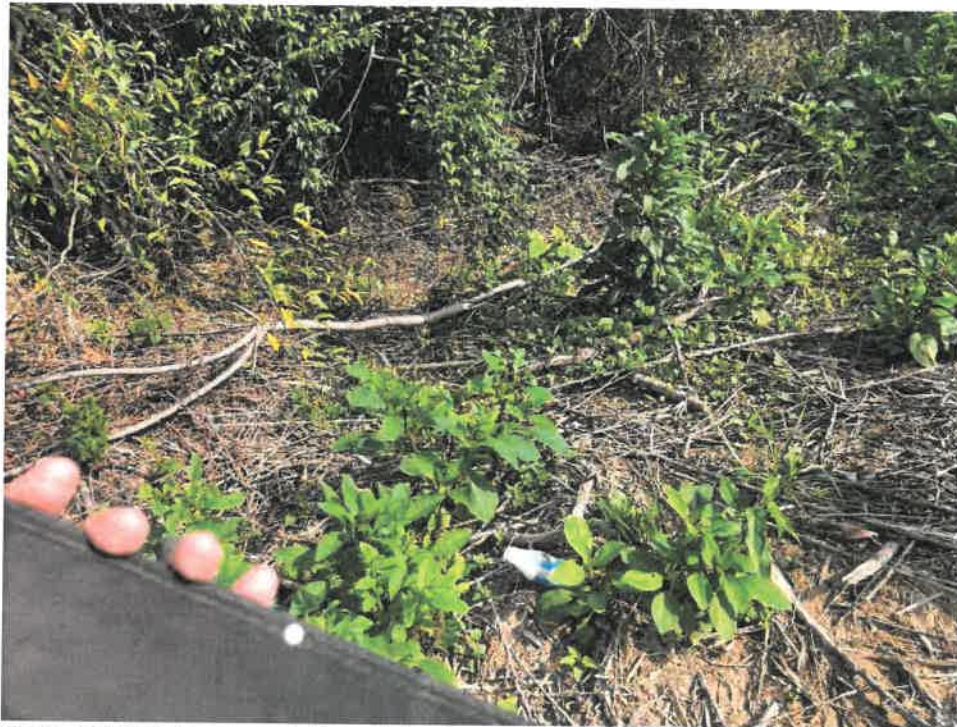
Photo 8: Typical representation of the Channel 4 near the confluence with Channel 3

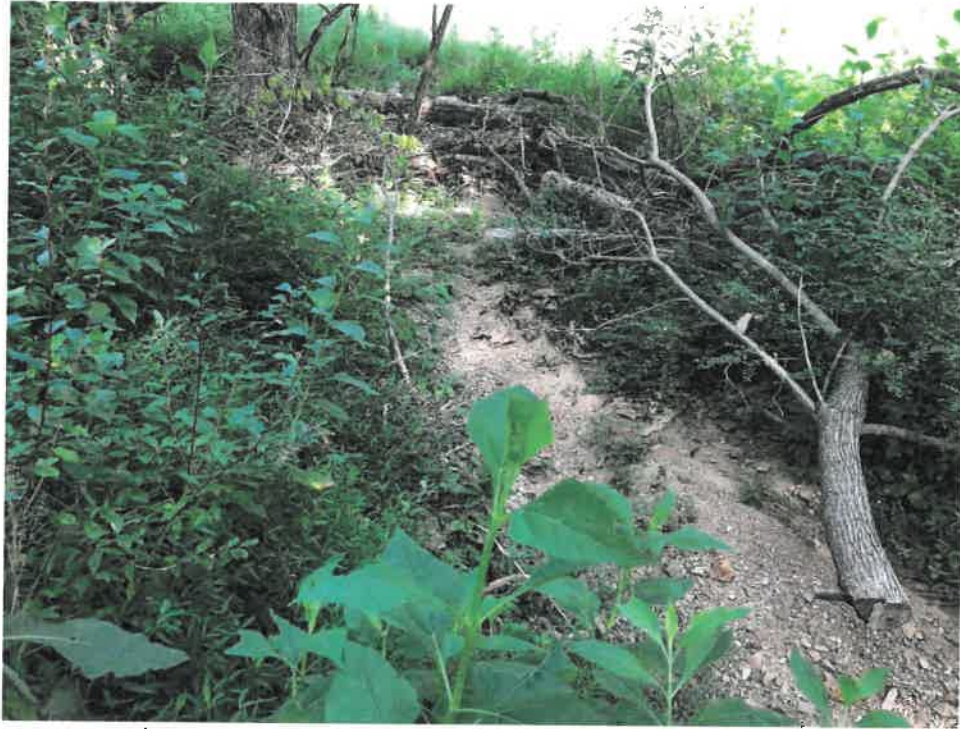
Photo 9: Photo of the Channel 5 as it enters the subject parcel

UT Hines Creek, Channel 5 – Wet Weather Conveyance due to secondary stream indicators; a secondary score of 18.0 was calculated using a rigorous and reasonable amount of effort.

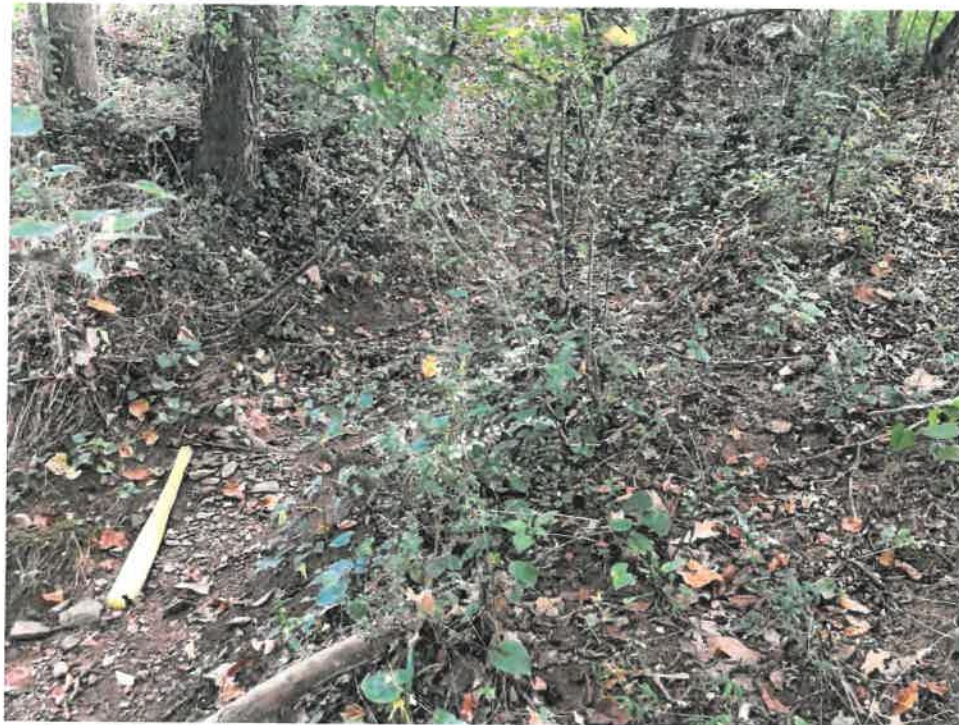
Photo 10: Typical representation of the Channel 5 midway through the property
