Subject: Limited Soil Gas Sampling
1155 & 1161 Copperwood Lane
Knoxville, Tennessee
UES Project No. A25109.01368.000

SITE PLAN
 COPPERWOOD LANE PHASE II
 1155 COPPERWOOD LANE
 KNOXVILLE, TENNESSEE

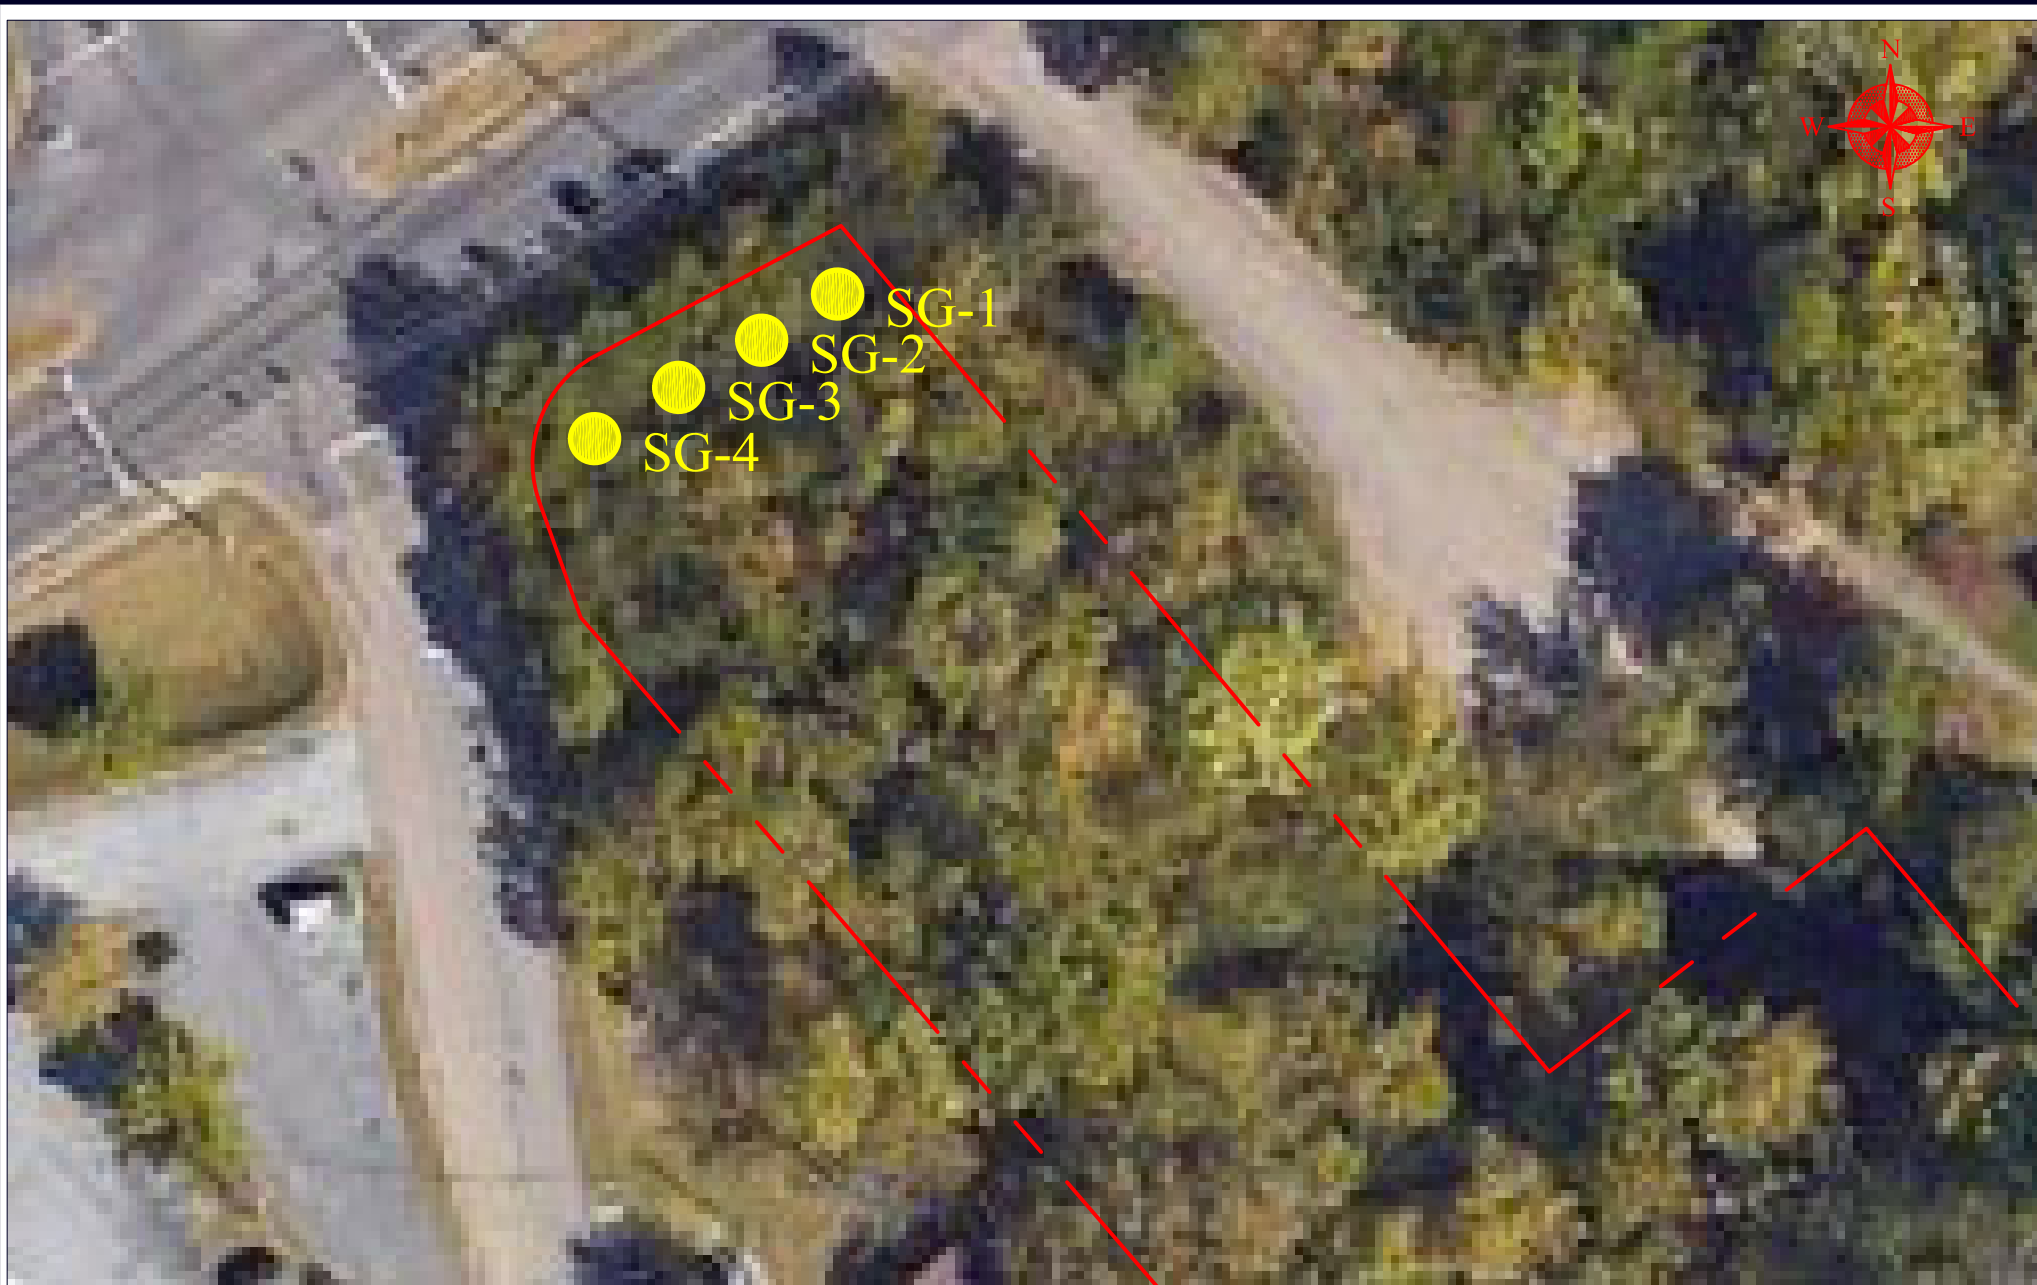
On April 1, 2026, UES personnel arrived at the site to conduct the proposed soil gas sampling activities. A total of four soil gas samples were collected (SG-1 through SG-4) along the northern property boundary that abuts Middlebrook Pike. A site plan was not provided, therefore the scope of work consisted of sampling along the property line located down gradient to the REC identified in Phase I ESA. Approximate locations of the sampling points are presented in **Appendix A, Figure 2**.

- Approximate Location of Soil Gas Samples.
- Subject Property.
