Gas station development with the possible impacts to the lake

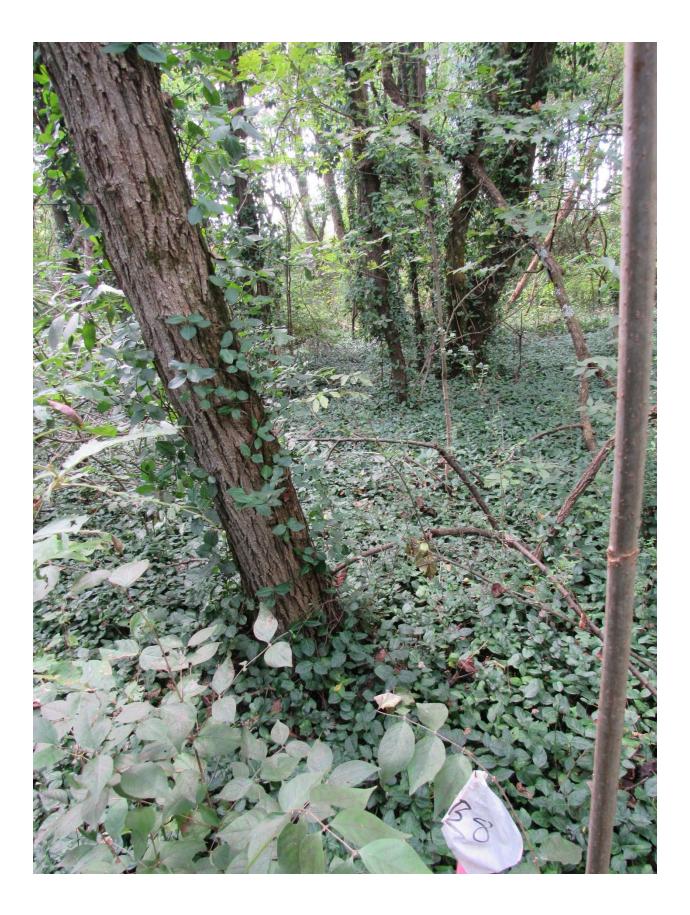
Field observations the of sink hole, suggests that no run-off water is being impounded in the sink hole which suggests that water directly infiltrates the sink hole soil and percolates to the underlying geologic strata of limestone caverns. This suggests that an active sink hole does exist.

Recently, there is no indication of water being retained by the closed basin. Surface water runoff was not retained after 5 inches of rainfall. There is no present indication of water loving plant species that grow in flood water basins. The plant species that currently grow in the basin would indicate that this is a well-drained basin with rainfall runoff rapidly infiltrating the soil and percolate through the soil into the sink hole caverns.

The B8 flag in the picture (taken October 2, 2024- two days after 5 inches of rainfall) is located at a geotechnical sample point in the sink hole. Notice no water loving plants are visible in the picture.

Since the proposed gas station is being built over this sink hole, special environmental concerns should be implemented to prevent a major pollution event that would affect the ground water. Best management practices should include **not** to allow a gas station to be built over this area.
